Abandoned Uranium Mine Site Assessment for the Section 21 Site (NM0135)

INTERA Incorporated (INTERA) has prepared this Abandoned Uranium Mine (AUM) Site Assessment Report for the Mining and Minerals Division (MMD) of the New Mexico Energy, Minerals and Natural Resources Department (EMNRD) in compliance with the Professional Service Agreement dated November 2, 2009. INTERA visited the Section 21 Mine Site (AUM Site), MMD ID: NM0135, on March 4, 2010.

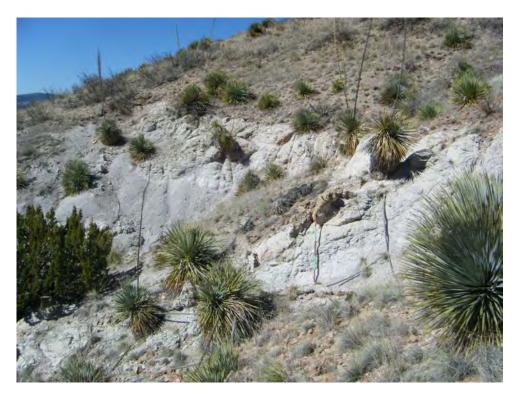
Photo 1-Looking southwest at the large erosion feature (ErosPt-1) located in the Northern Area.

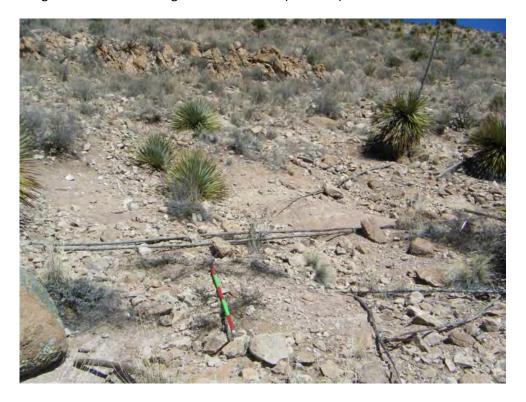
Photo 2-Looking north at the open cut (CutPly-1) located in the Northern Area.

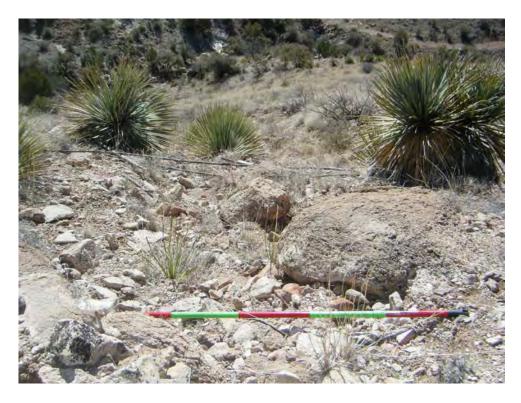
Photo 3-Looking south at the erosion feature (ErosPt-2) located down slope of CutPly-1 in the Northern Area.

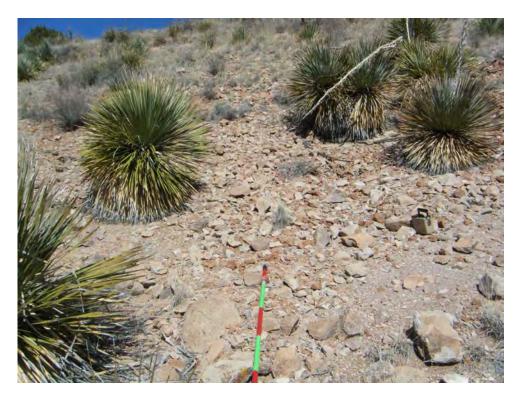
Photo 4-Looking north at the open cut (CutPly-2) located in the Northern Area.

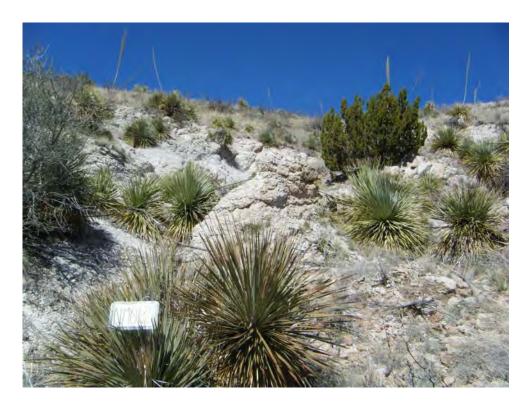
Photo 5-Looking northwest at the base of erosion feature (ErosPt-1), site name location in the Northern Area.

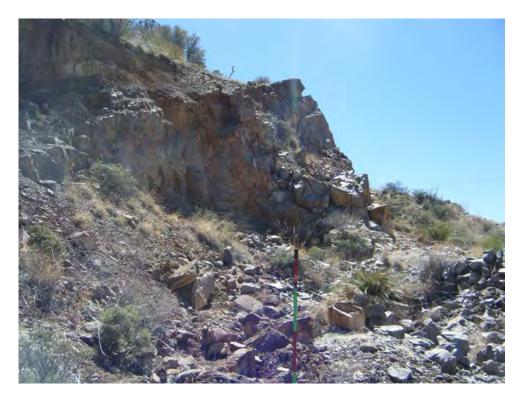
Two open cuts (CutPly-1 and CutPly-2) were identified at the Northern Area of the AUM Site; these cuts appeared to be only exploration cuts since no material appeared to have been removed from the site. Two open cuts (CutLn-1 and CutLn-2) were identified at the Southern Area of the AUM Site. CutLn-1 was a cut into the northwest side of the hill approximately 60 feet in length and the exposed rock face was about 15 feet high. CutLn-2 was a cut into the southeast side of the hill approximately 40 feet in length and the exposed rock face was about 20 feet high.

Photo 7- Looking south at an Open Cut (CutLn-1) located in the Southern Area.

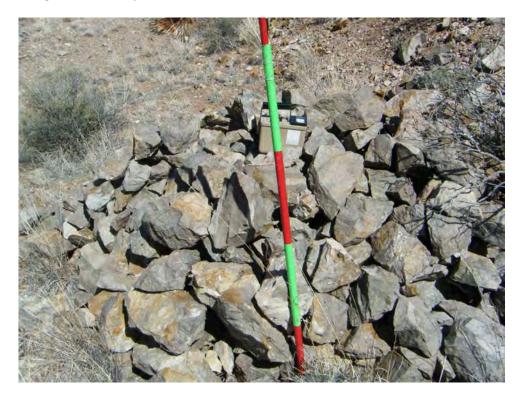
Photo 10-Looking east at a waste pile (PilePly-1) located in the Southern Area.

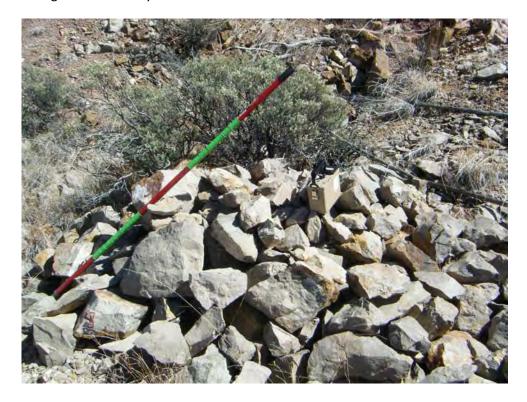
Photo 12-Looking southeast at a waste pile (PilePly-2) located in the Southern Area.

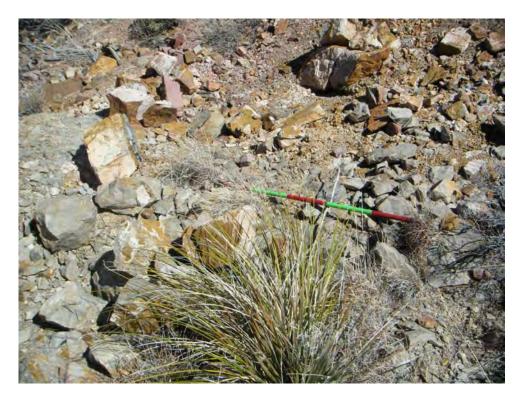
Photo 13-Looking southeast at a waste pile (PilePly-3) located in the Southern Area.

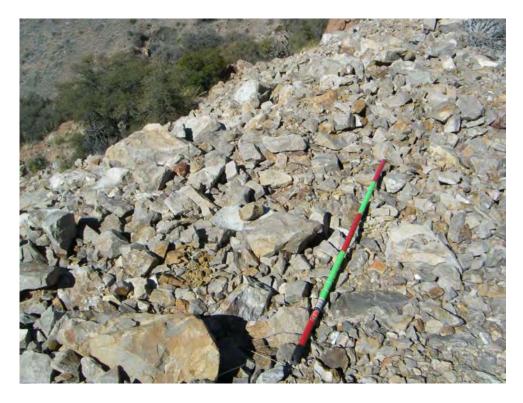
Photo 15-Looking east at pileridge-1 located in the Southern Area.

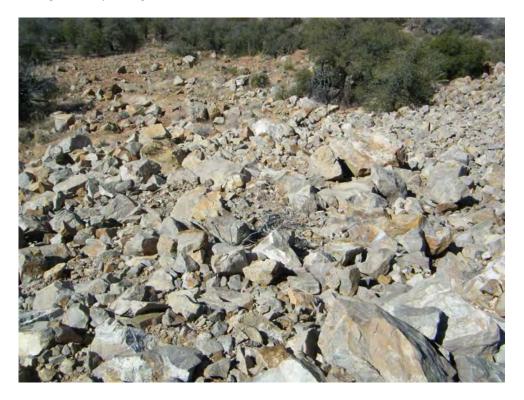
Some gullying and downward movement of waste rock was observed at the Southern Area of the AUM Site.

Photo 16-Looking north at the down slope of pileridge-1 located in the Southern Area.

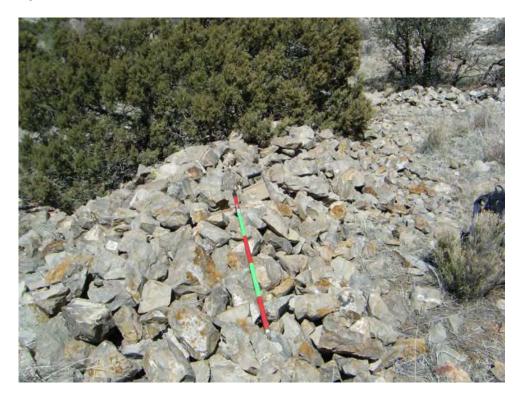
Pileridge-2 is associated with DistPly-1 which was flattened and was unvegetated. Pileridge-2 material appears to have originated from CutLn-1 and CutLn-2.

Photo30- Looking north at pileridge-2 located in the Southern Area.

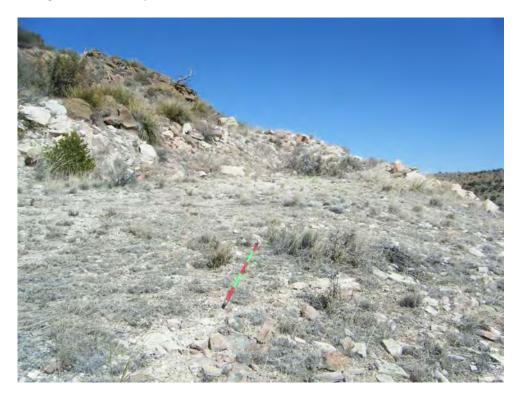
Photo 33-Looking northeast at DistPly-1 located in the Southern Area.

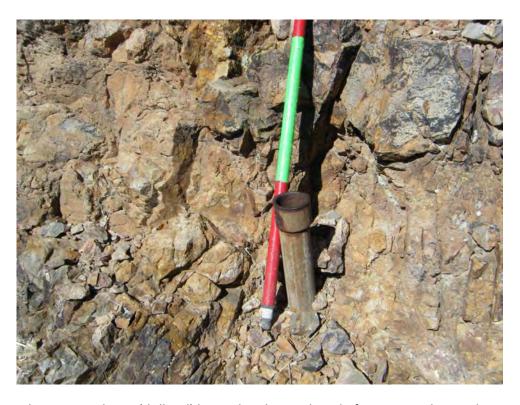
A metal pipe (Photo-7), potentially a drill rod, was observed at the northern end of CutLn-2. It was reported that the Southern Area AUM Site contained three diamond drill holes (Hedlund, 1978). No other evidence indicating boreholes was observed at the Southern Area AUM Site.

Photo 34-Looking at metal pipe (drill rod) located at the north end of CutLn-2 in the Southern Area.

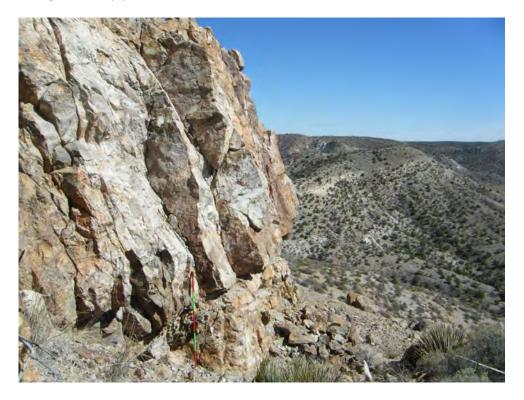
Photo 35-Looking east at CutLn-2 located in the Southern Area.

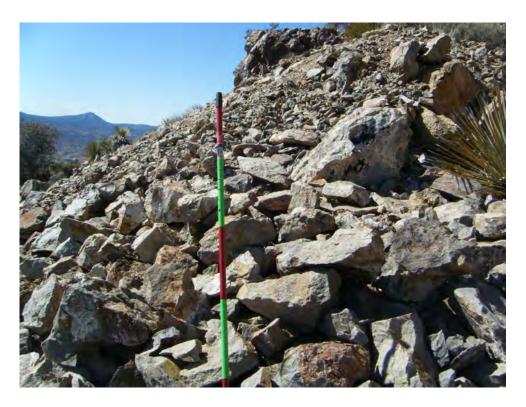
Pileridge-3 and pileridge-4 are associated with CutLn-2. Pileridge-3 spills down the south side of the ridge on which CutLn-2 is located. Pileridge-4 is the southern down slope boundary of pileridge-3.

Photo 36-Looking north at pileridge-3 located in the Southern Area.

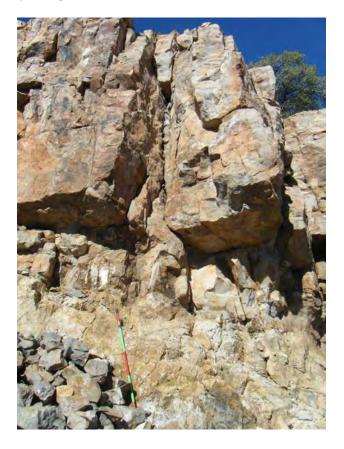
Photo 37-Looking north at the rock face of CutLn-2 located in the Southern Area.

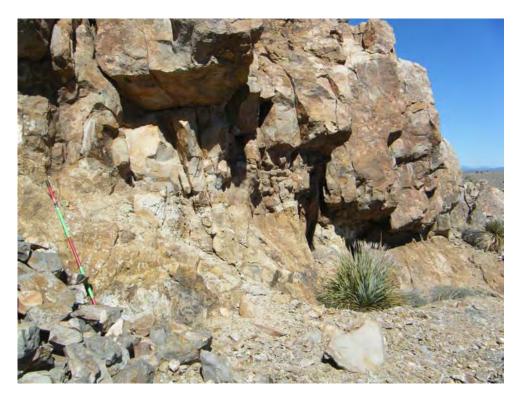
Photo 38-Looking southeast at the rock face of CutLn-2 located in the Southern Area.

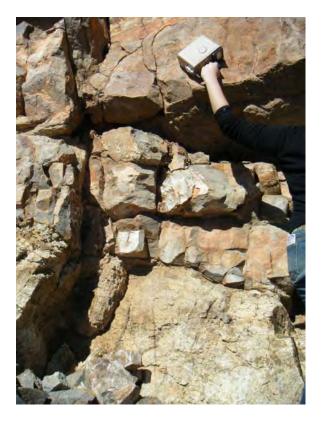
The gamma radiation readings at the Northern Area AUM Site did not vary significantly above background levels (Table 2). The gamma radiation readings at the Southern Area AUM Site were greater than background readings. The maximum gamma radiation reading was taken at CutLn-2 and was measured at 260 μ R/hr at the ground surface and 90 μ R/hr at 4 feet above the ground surface. The average gamma radiation readings taken at the Southern Area was 116 μ R/hr at the ground surface and 44 μ R/hr at 4 feet above the ground surface.

Photo 39-Taking a reading on the rock face of CutLn-2 in the Southern Area.

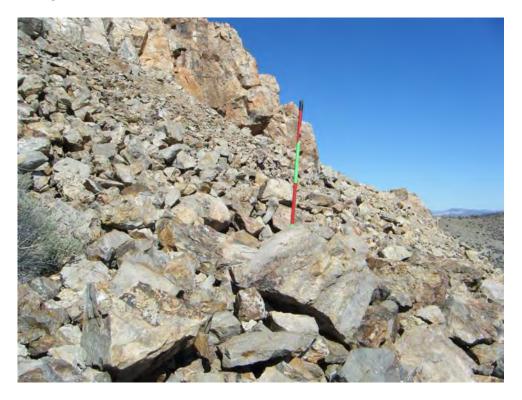
Photo 41-Looking northeast at the pileridge-4 which is the base of spill over from pileridge-3 located in Southern Area.

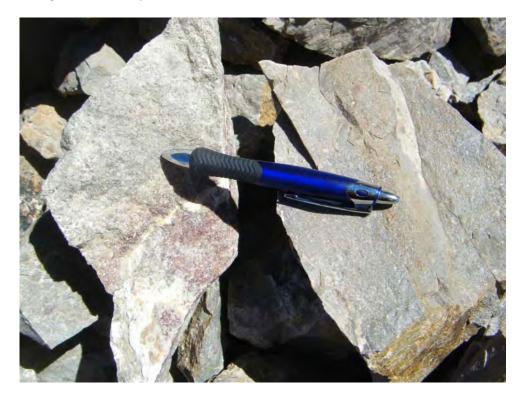
Photo 43-Looking at the type of rock found in the waste piles in the Southern Area AUM Site.
